Manhole Inspection Summary

Manhole # S21II_017MH

Insp Date: **6/25/07 9:59 AM**

Location Address: **1734 FULTON-BRUCE**

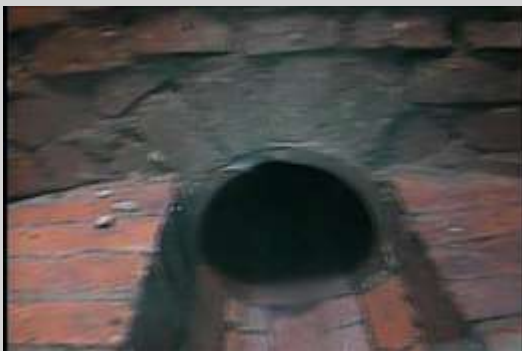
6 O'Clock Inflow

8 in. Circular Gravity Sewer
Pipe In @ 6 O'Clock

Pipe Height: **8.4** (in.) Rod and Bar (Angled)
Pipe Material: **Clay** ☐ Pipe Lined
Invert Depth: **7.96** (ft.) Flow Characteristics: **Slow**
Deposits: ☒ None ☐ Mud ☐ Sludge ☐ Debris ☐ Grease
Silt Depth: (in.) Deposits Extent:
Infiltration: **None** Pipe Seal Cond: **Sound**

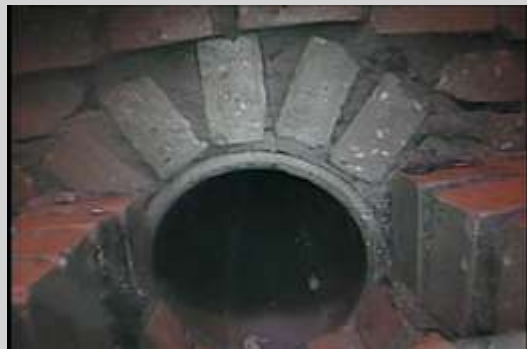
9 O'Clock Inflow

8 in. Circular Gravity Sewer

Pipe In @ 9 O'Clock

Pipe Height: **8.4** (in.) Rod and Bar (Angled)

Pipe Material: **Clay** ☐ Pipe Lined

Infiltration: **None** Pipe Seal Cond: **Sound**
